Bergman & Associates, Inc.

Reference: Roof Inspections - Buildings A, B and C

10 December 08

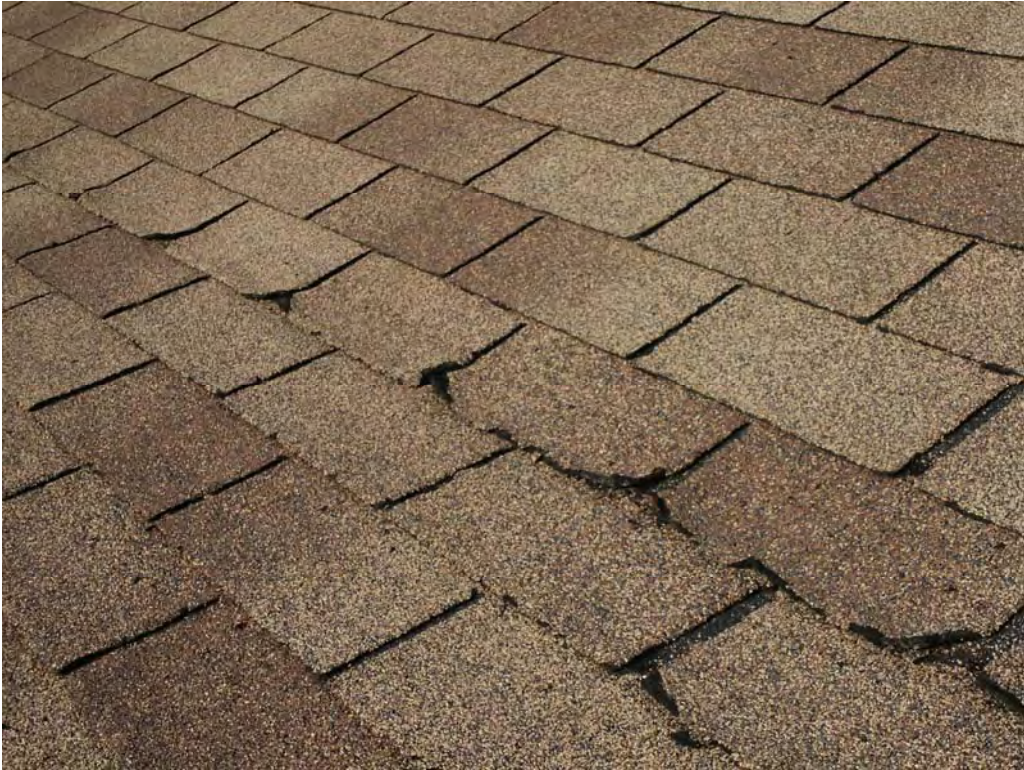
PHOTO 1

The south-facing flat roof is in very poor condition. (See photo 1) Pieces of three (3) shingles are missing, and there are exposed roofing nails. (See photo 2)

Generally speaking, the roofs are in fair to poor condition. All three (3) flat roofs were in poor condition. From visual inspection of the roof planes, there are indications that there may be some underlying sheathing or framing issues. These concerns can be investigated further when new roofs are installed. Any deficiencies can be addressed at that time.

Page 3 - Report to Farrwood Green II Condominium Association, c/o Ms Elaine Romano
would recommend that the Association undertake reroofing of all three buildings.

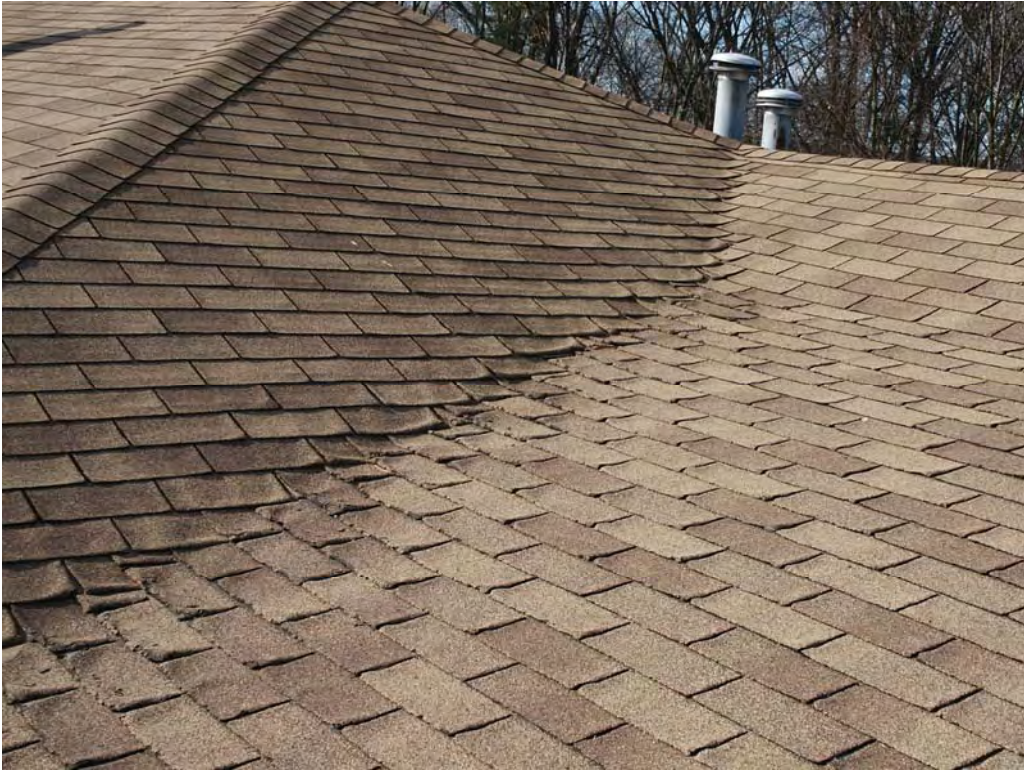
PHOTO 3

The valleys are very heavily degraded. (See typical photos 3 and 4)

All of the valleys had signs of degradation, some significant. We suspect that insufficient ventilation may be the cause of this deterioration. This may also be the case for the flat roof failures.

It is impossible to certify that any given roof will never leak over a period of time. At this time, however, we recommend that all the valleys be swept clean and coated with a thick layer of roofing cement. This should prevent leaks in these areas through the winter period. In 2009, we

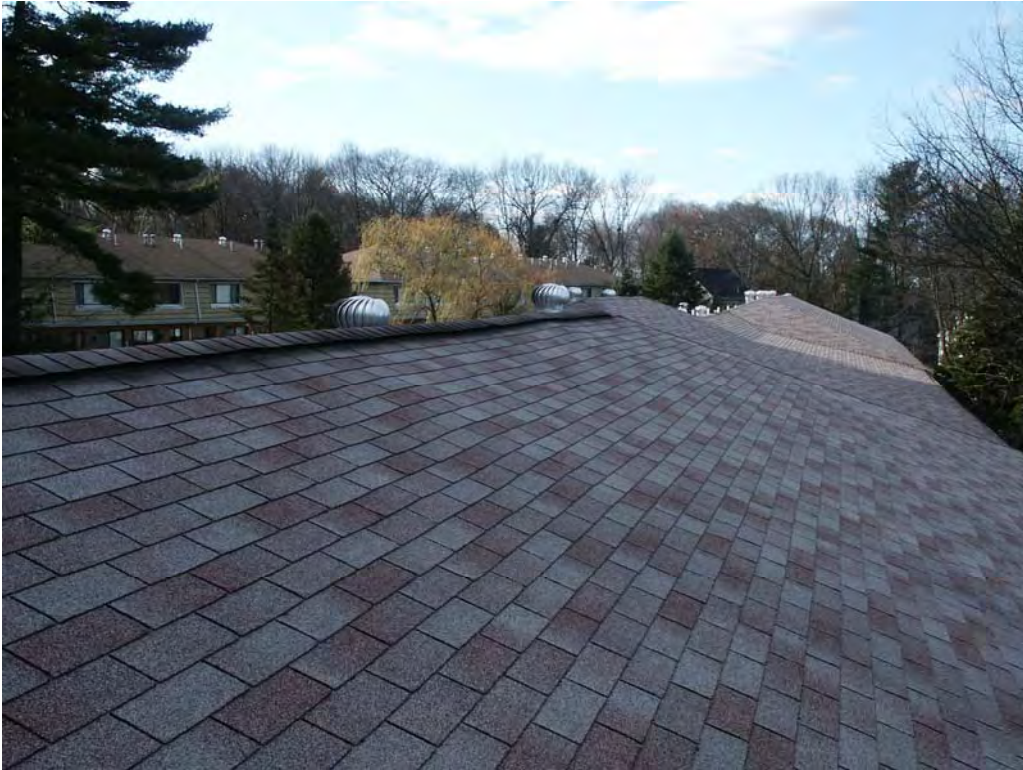
PHOTO 5

We observed that the roof has "waves", or lifted sections of the roof sheathing. (See typical photo 5) These areas appear to coincide with the unit demising walls below. While these waves may not affect the performance of the shingles, we recommend that this phenomenon be investigated during the reroofing. Normal roof planes should not have these discontinuities.

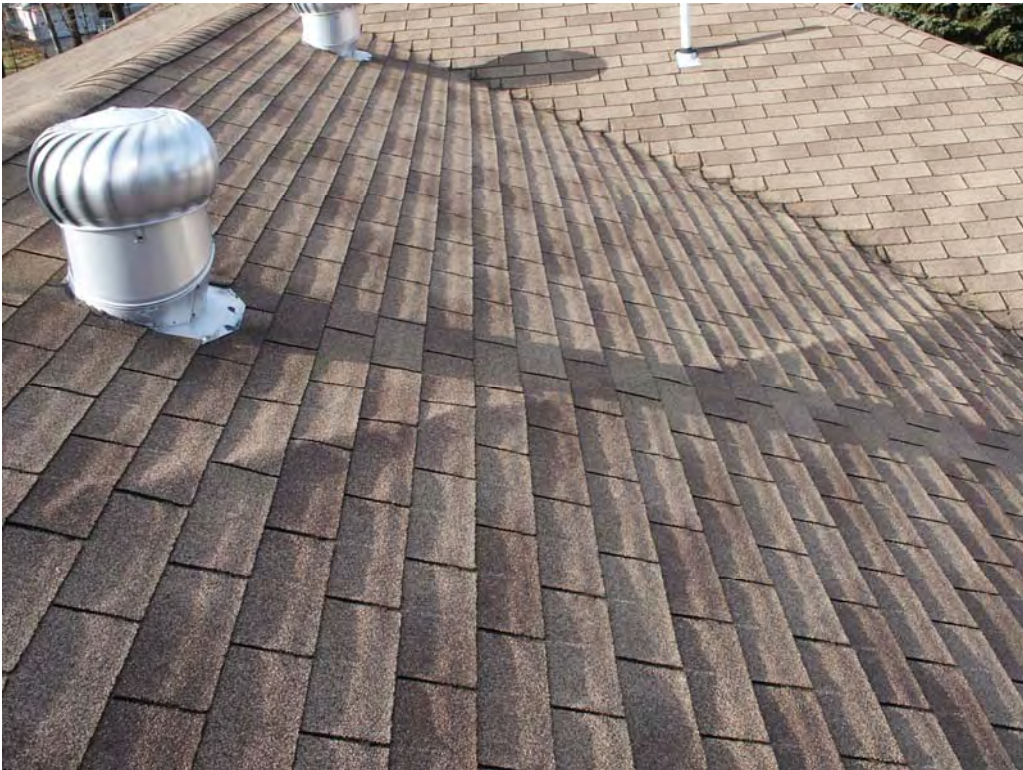
PHOTO 6

On this particular roof, we noticed an odd diagonal ridge/undulation in the roof plane. (See photo 6)

Undulations in the roof, similar to Buildings A and B, were noted in this building also. Additionally, we noticed several soft spots while walking on the roof. Both of these issues will need to be investigated during the reroofing work.
