**EXTERIOR SIDING
CONDITION SURVEY**

FOR
FARRWOOD 2 CONDOMINIUMS
49-176 FARRWOOD DRIVE
HAVERHILL, MA

APRIL 2016

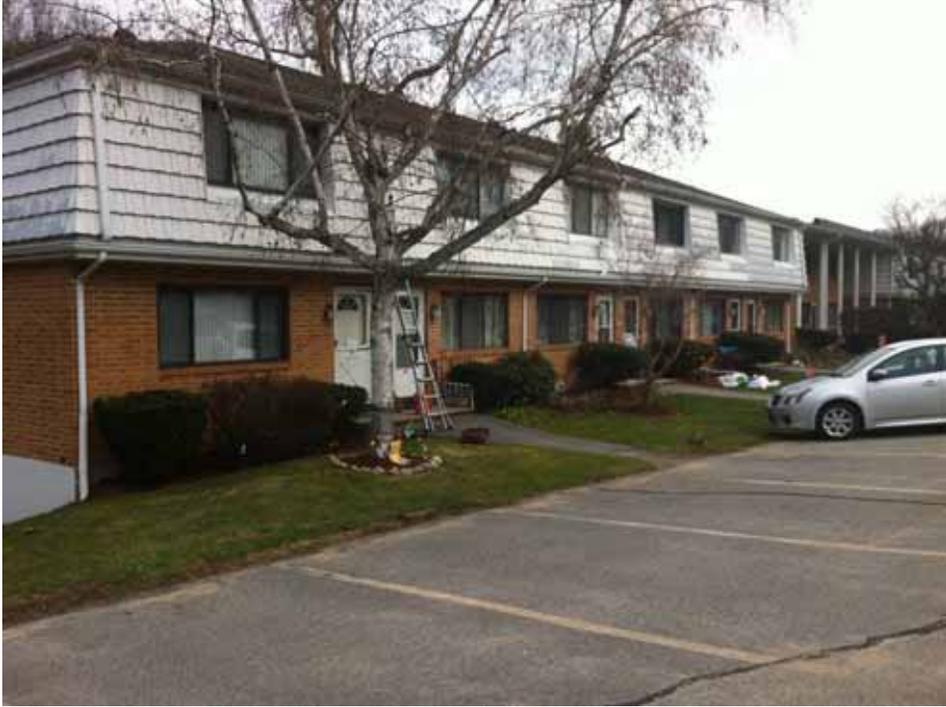
Partial view of Building A located on the Farrwood 2 property.

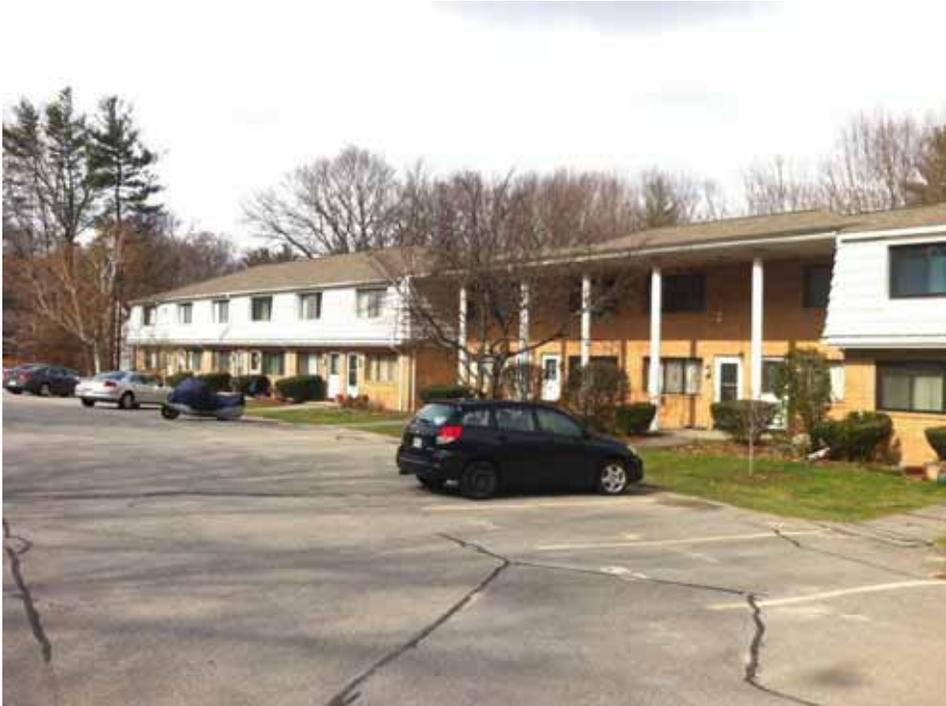
Additional view of the building's exterior components.

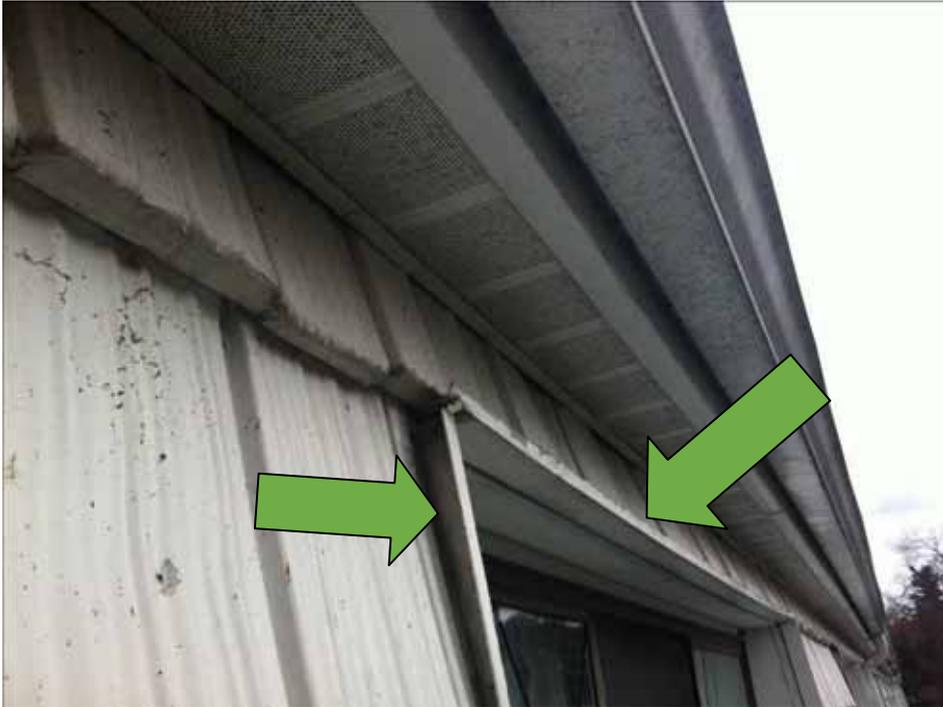
- The field fabricated aluminum sheet metal boxes installed around each window are in poor condition. The sheet metal shows evidence of oil canning, damaged and poorly fabricated. There is no formal flashing installed at the head of the boxes and in many cases the sheet metal flange turns up, allowing water to travel back towards the building at the top of each window.

Existing windows are encapsulated in aluminum sheet metal 'box' style trim. Note the sagging header above the window, trim not flush at jambs.

with interior temperatures on the second floor which could be related to how the interior walls are insulated. The siding currently installed adds no insulating value to the building envelope. The recessed aluminum window boxes are in poor condition and should be considered for replacement.

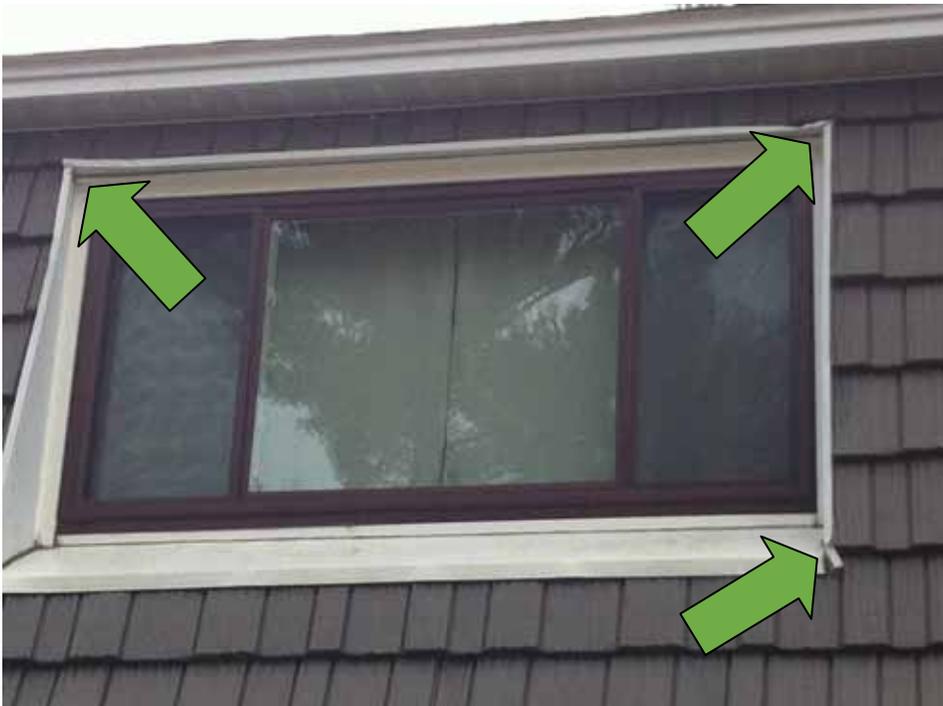
Box out trim installed around windows is dented/contains poorly fabricated corners.

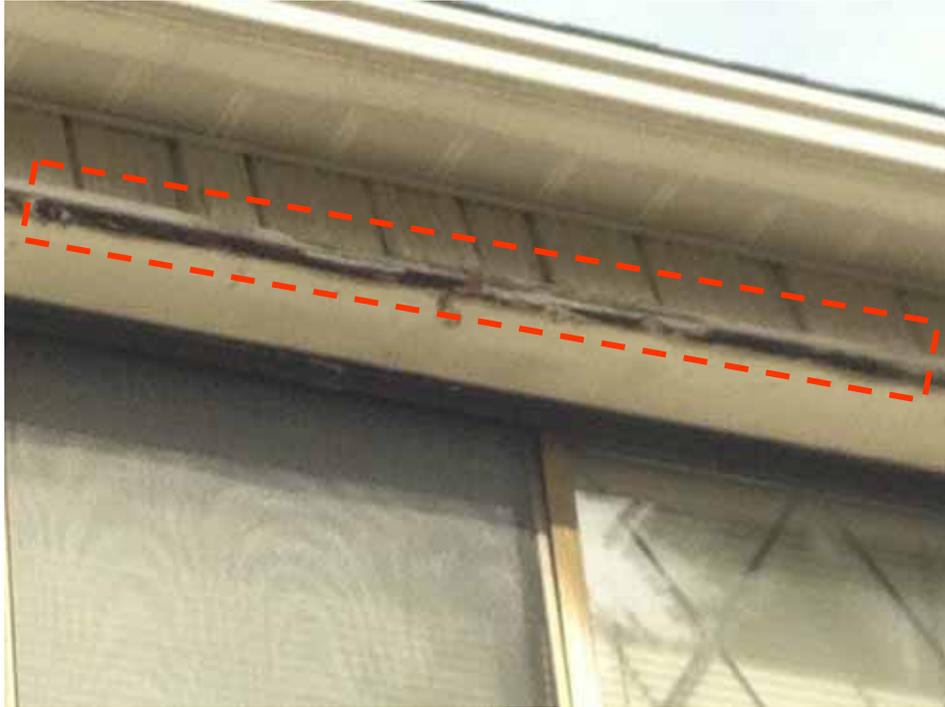
- In many cases, a wood header board is installed on the outside of the window boxes. The board has deteriorated in many locations and it is unclear what purpose the lumber serves. These may have been installed as a repair to correct a sagging condition that was visible at the top of the window box metal in some locations. It appears that the board was once fastened through the box metal and into framing but has lost securement in areas. Attempts have been made to seal between the top of the board and the boxed in aluminum trim. These sealant repairs have deteriorated as well.

View of wood board spanning along the head of one window. Sheet metal behind it is damaged and an attempt was made to seal between lumber and box metal.

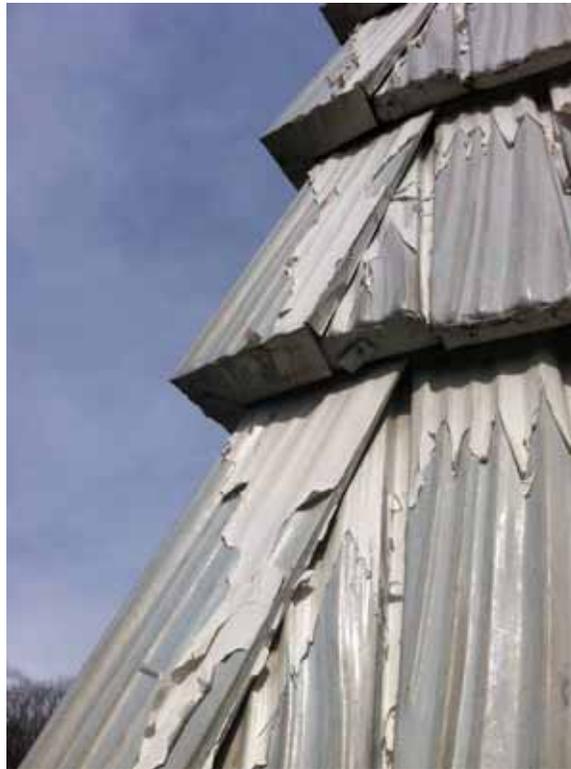
- Paint has peeled away from approximately 70% of the siding on Building A&B. Paint degradation is most prominent on the front elevation of Building A and throughout most of Building B. The paint is considered in good condition on the other buildings throughout the property.

- The shingle style outside corners are installed with individual tabs securing each corner piece to the end of the siding installed in the field of the building elevation. The individual corner tabs are loose and relatively easy to pry open. Due to the open condition at each corner, multiple bee hives were identified beneath the siding at each corner throughout the entire length (roughly 8' at each corner). This condition applies to all buildings on the property, however, Buildings A&B contain the most severe instances.

Close-up of the aluminum siding at the corner of Building A. Note the extensive peeled paint and loosely joined corner pieces.

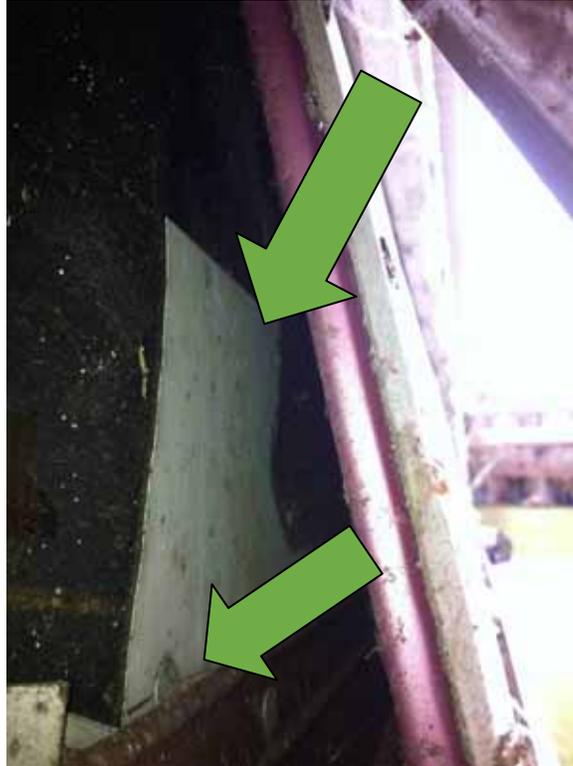
- Buildings A, B & E contain a tar paper underlayment over the existing plywood substrate. The tar paper is generally not continuous at the outside corners and does not wrap around the limits of the plywood panels. The underlayment types vary at the other buildings but is considered continuous along the outside corners of the siding.

View behind the siding showing a partial piece of sheet metal fastened into the substrate. Tar paper underlayment was not continuous at this particular corner.

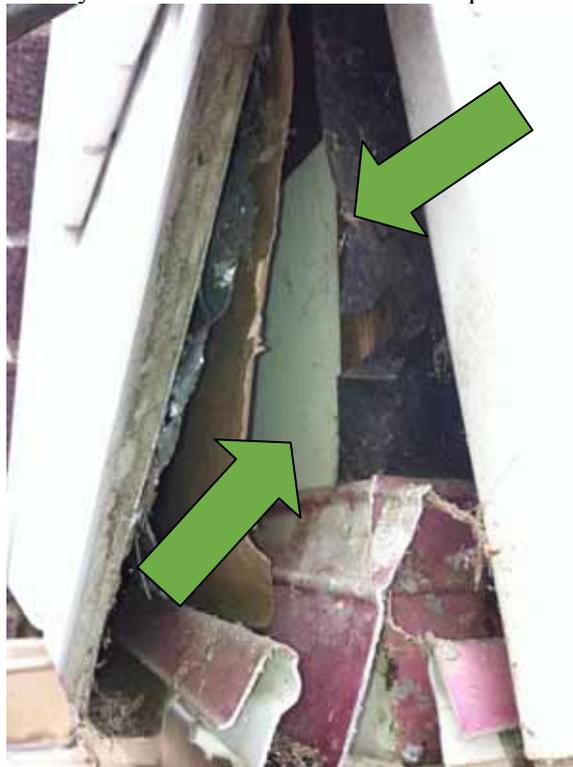
View of inconsistent, non-continuous underlayment material behind siding of Building E.

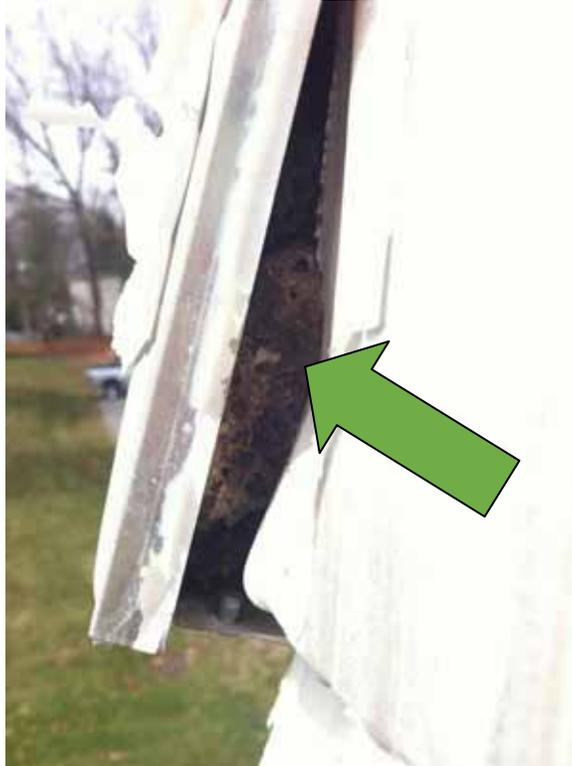
View of old bee hives tucked behind the open siding at the corner of Building B.

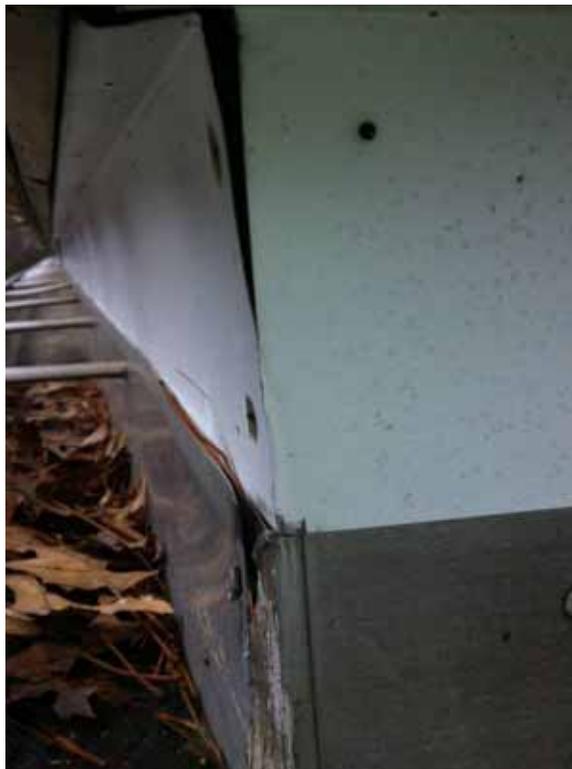
Partially open sheet metal apron flashing corner above gutter of Building C.
