RESERVE BUDGET ANALYSIS

FARRWOOD GREEN II CONDOMINIUM HAVERHILL, MASSACHUSETTS

DATE: July, 2008

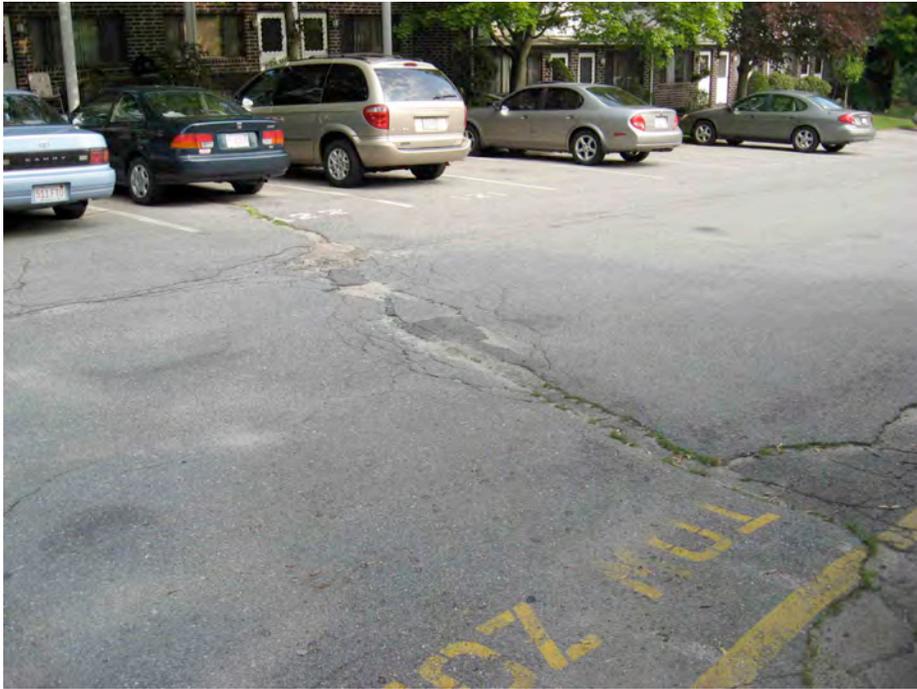
At the time of our site inspections, the existing pavement appeared to be in generally fair to poor condition. Several deficiencies were noted including cracking of the pavement surface, potholes, damage to the bituminous berms and oil stains in various areas (see Photograph #1).

Photograph #1 – Cracked And Settled Bituminous Pavement

Removal and replacement of the existing pavement, with some subgrade preparation has been assumed. Lining of pavement at the time of repaving has been included.

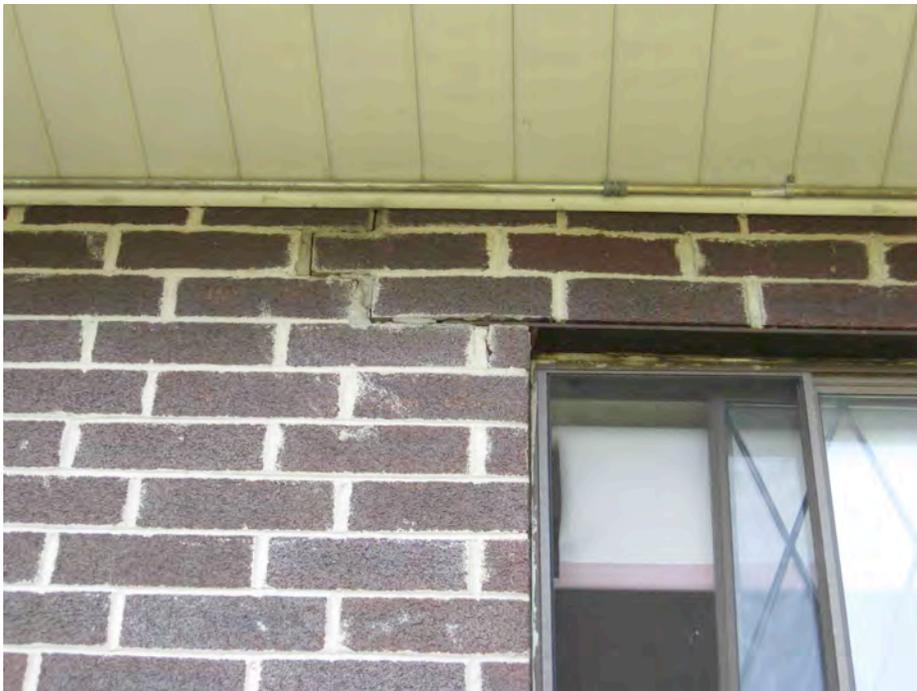
The masonry veneer walls we noted to be in generally good to fair condition at the time of inspection. Minor to moderate cracking of the masonry mortar joints, particularly at building corners and window openings, was noted in various areas including at Buildings 49-64, 65-80 and 113-128 (see Photographs #2 and #3). Moderate corrosion of the steel lintels was also noted in most areas.

Photograph #2 – Cracked And Displaced Brick Masonry At Lintel End

Partial (10%) repointing and other repairs to the masonry have been assumed to maintain the integrity of the masonry surface.

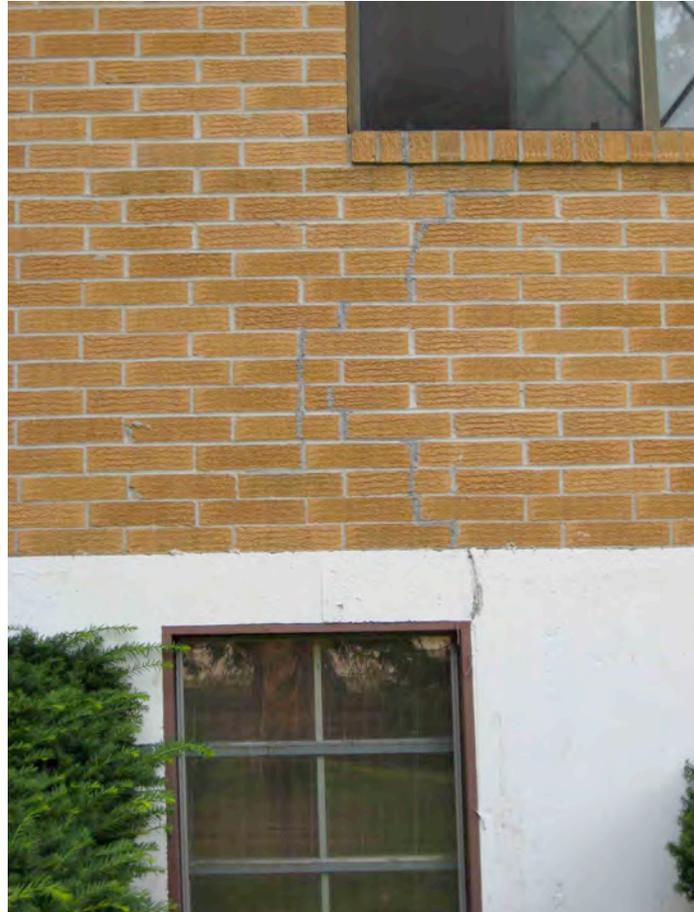
Photograph #3 – Cracking Of Brick Masonry And Foundation Wall

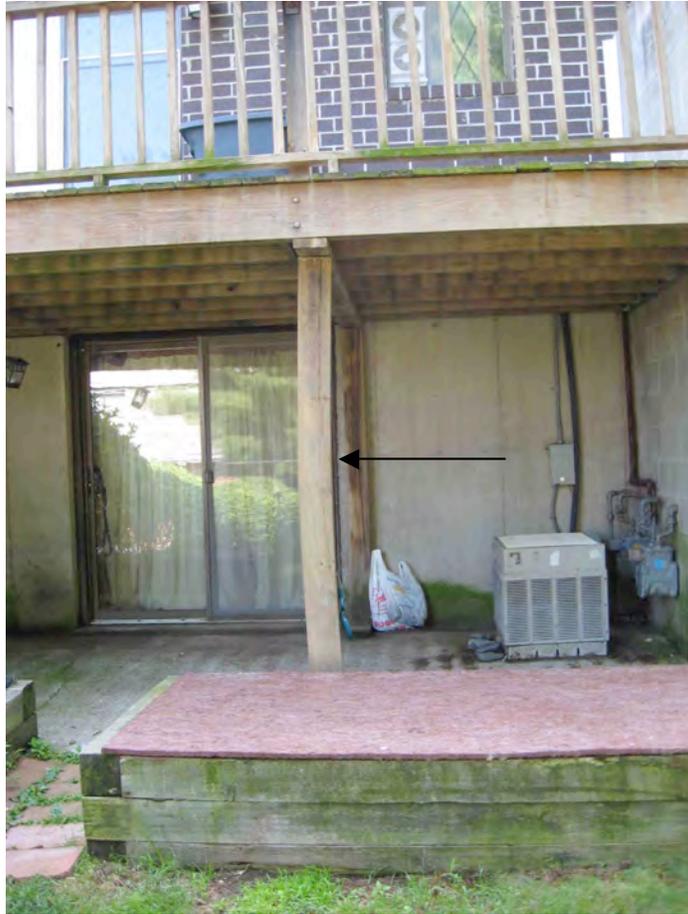
Wood posts were noted to have been installed near midspan below the doubled band joist on end Unit decks (see Photograph #4). Wood joist span calculations performed utilizing the current Massachusetts State Building Code required 60 lb./s.f. live load for decks of this type indicate that the

existing 2 x 10 joists at end Unit decks, spanning 19'6", are significantly overloaded.

Photograph #4 – Wood Post Below Band Joists At End Unit Deck. Note Bowing Of Post.

Replacement of the existing wood decks has been assumed. This includes the cost of reinforcing the existing CMU block support walls and securing the CMU walls to the building foundation walls. Decks at Buildings 49-64, 81-96, 113-128, and 161-176 have been assigned longer service lives than decks at Buildings 97-112 and 129-144 due to conditions noted during inspection.

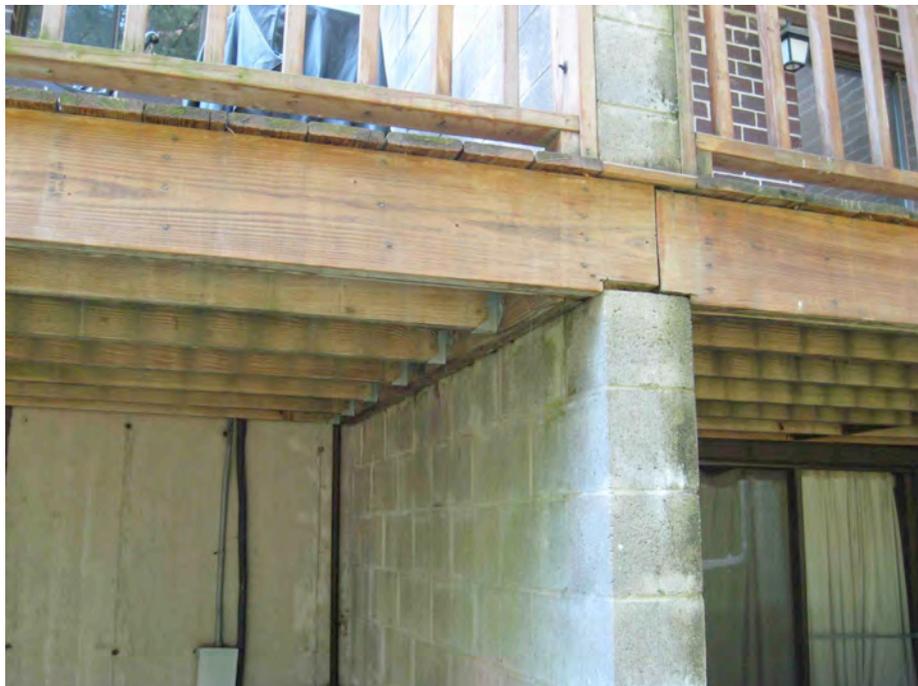
All decks appear to be constructed of pressure treated lumber. Deck frames consist of 2 x 10 joists @ 16" o.c. fastened to 2 x 10 ledgers bolted to the CMU block walls (see Photograph #5). Railings typically consist of 2 x 2 balusters @ 5 1/2" o.c. with 2 x 4 rails and 4 x 4 posts. Connections between deck framing members have been made with galvanized metal joist hangers. Wood decks were noted to be in generally good to fair condition at the time of inspection. Minor to moderate deterioration of the existing railings and outside band joists was noted, including twisting, cracking and checking of the exposed 2 x 10 band joists.

Photograph #5 – Wood Deck Joists Attached To CMU Wall

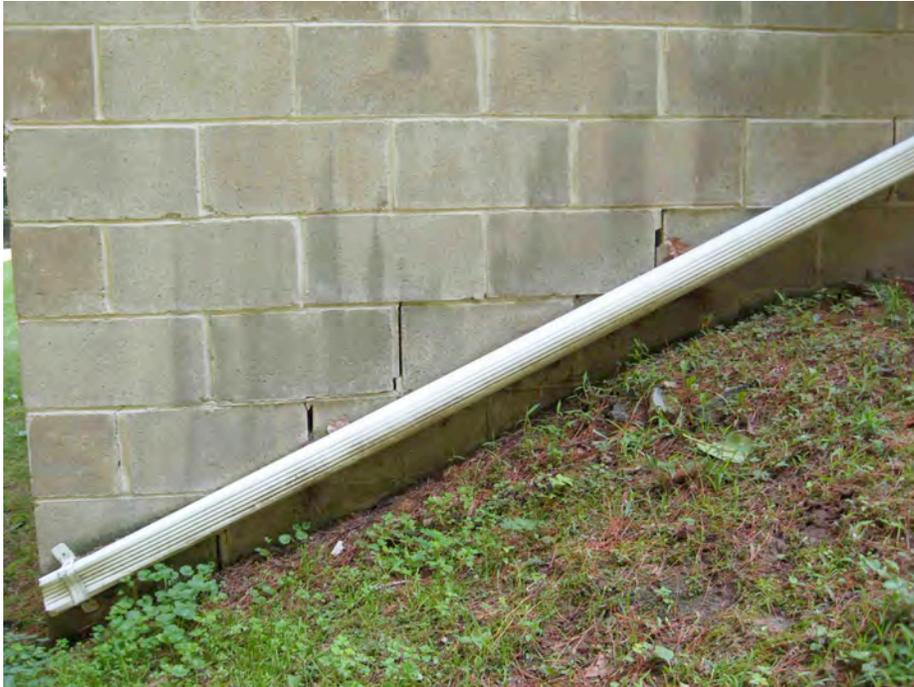
CMU block walls supporting the decks were noted to be in generally good to fair condition at the time of inspection, with the exception of the wall supporting the exterior side of the deck at Unit 128 (see Photograph #6). Significant step cracking and displacement of the CMU block was noted in several areas near the base of the wall. It should be noted that, the CMU walls did not appear to be attached to the adjacent building foundation walls in most areas (see Photograph #7). This configuration would provide minimal lateral support to the deck assemblies.

Photograph #6 – Cracked And Displaced CMU Block Wall At Unit 128

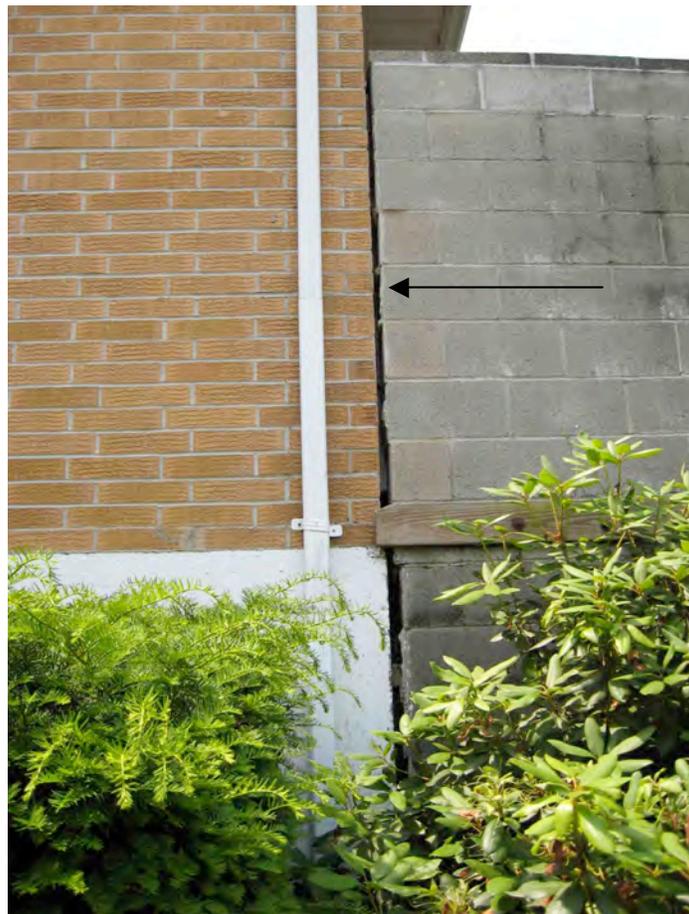
Photograph #7 – Note Gap Between CMU Block Wall And Building Wall

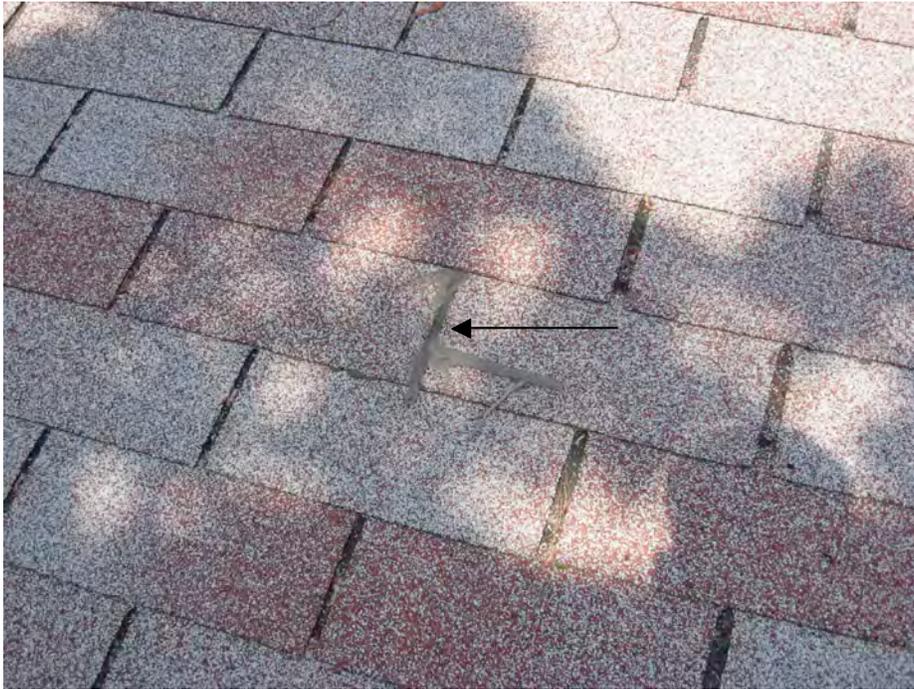
Direct inspection of the roof surfaces on Buildings 49-64, 97-112 and 113-128 revealed organic mat, three tab asphalt shingles. Shingles in most areas were noted to have been installed with joints lining up in every second course, or "racked". It is generally recommended that shingles be installed with joints lining up every sixth course to increase the strength and overall watertightness of the shingle surface and reduce the aesthetic effect of minor variations in shingle color and texture. Severe deterioration of the shingle surfaces was noted at the valleys between roof planes on all three buildings, as was moderate deterioration of the shingle surfaces in field areas (see Photographs #10 and #11). Missing shingle tabs and sealant repairs were also noted in various areas (see Photographs #8 and #9).

Photograph #8 – Sealant Repairs To Asphalt Shingles

Reroofing with a moderate to heavy weight shingle has been assumed. Reroofing is assumed to include removal of original shingles to allow inspection of the plywood deck for possible deterioration or inadequate fastening.

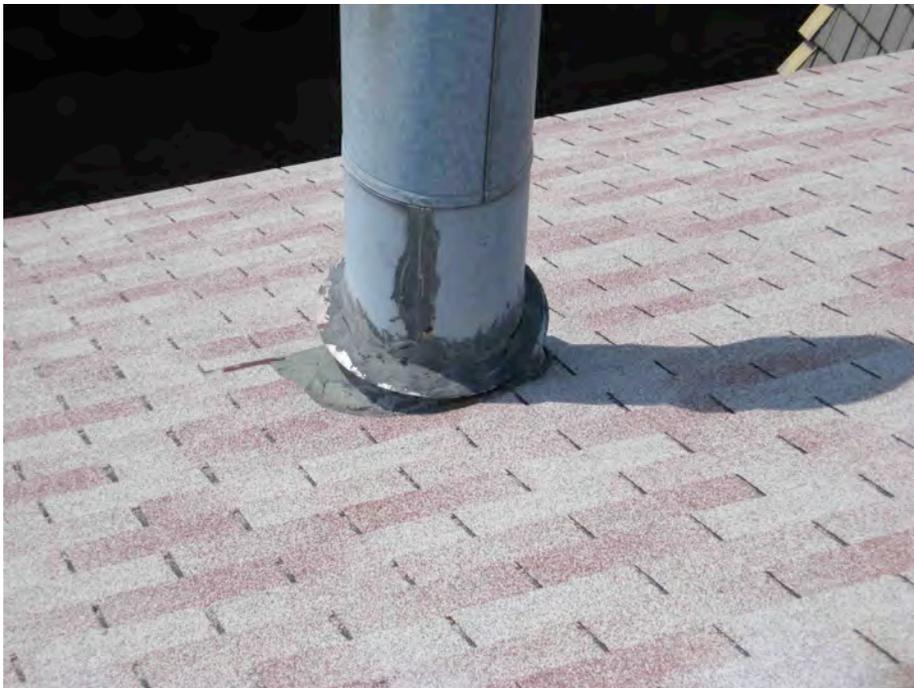
Photograph #9 – Mastic Repairs To Metal Furnace Vent

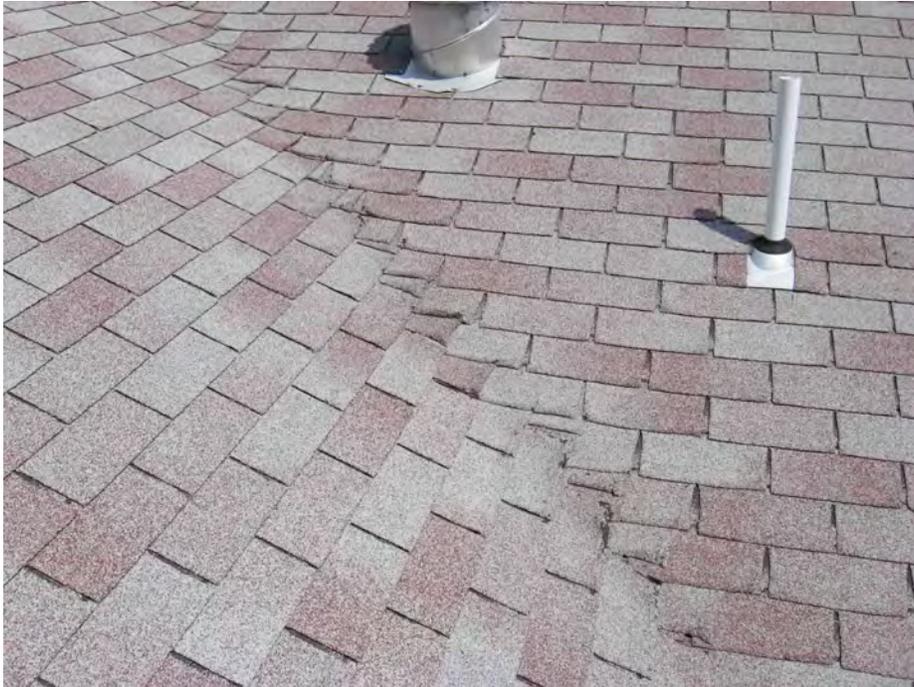
The roofs on most buildings were noted to be in generally fair to poor condition with moderate to severe deterioration of the exposed shingle surfaces, particularly near the roof eaves and at the woven valleys. The architectural style shingles on Building 161-176 appeared to be in generally good condition.

Photograph #10 – Deteriorated Shingles At Woven Valley

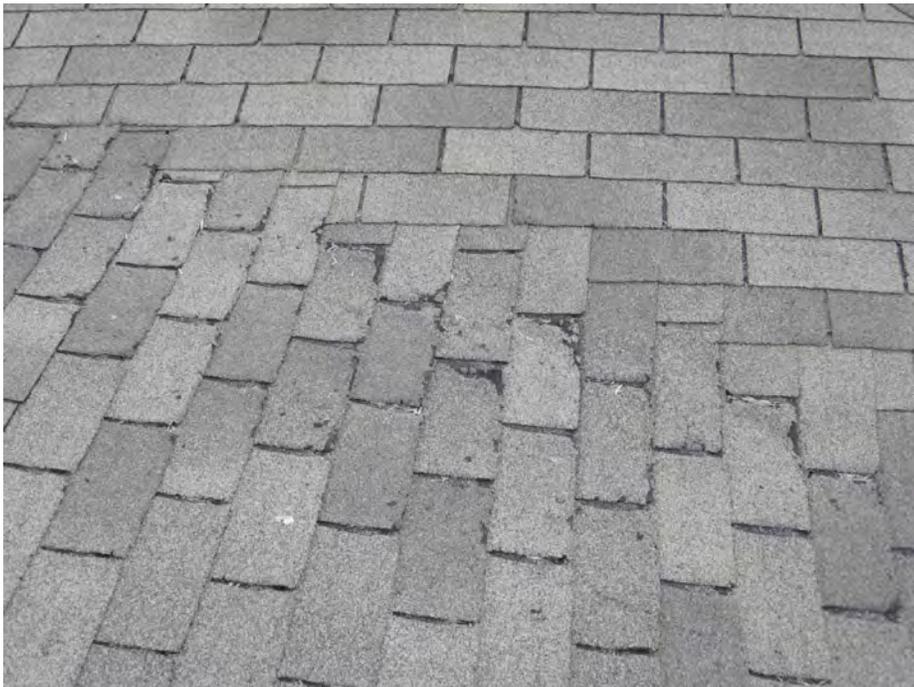
Photograph #11 – Deteriorated Shingles At Woven Valley

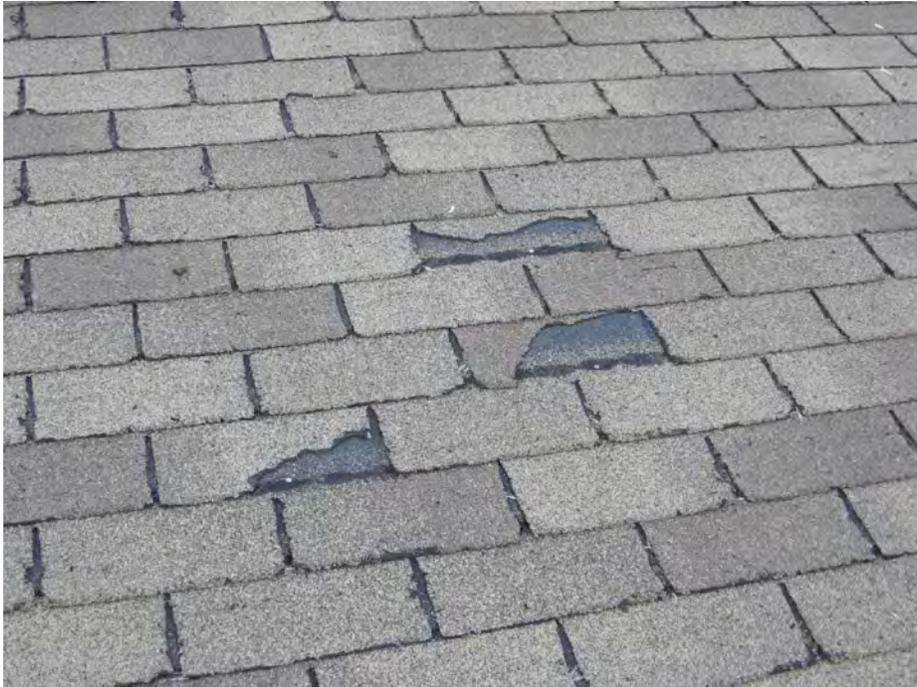
Photograph #12 – Broken Shingle Tabs

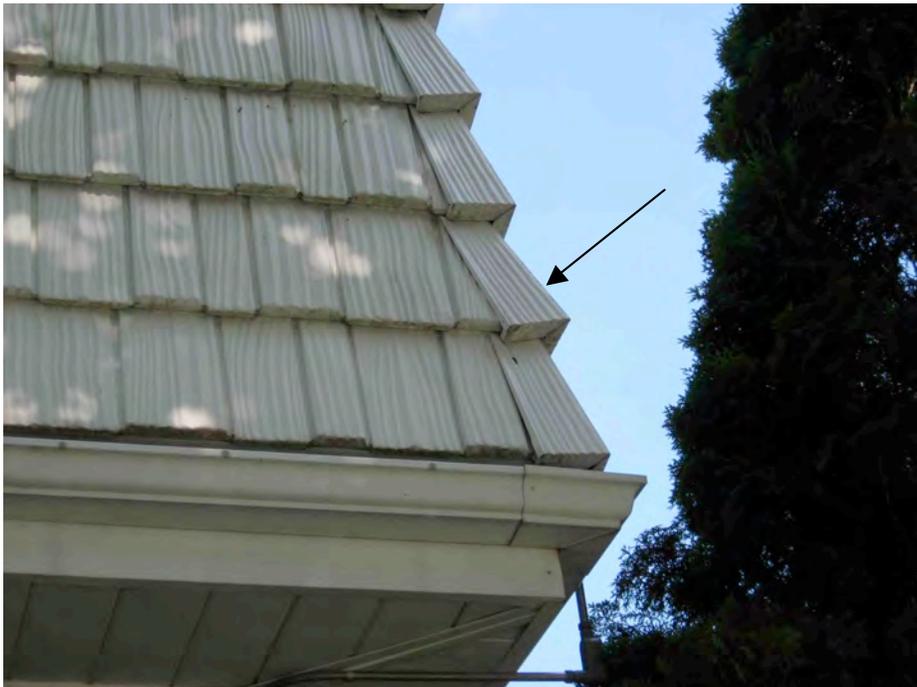
Metal panel roof systems were noted to be in generally good condition in most areas. Minor displacement of the hip cap shingles was noted in various areas (see Photograph #13). Significant finish failure including peeling of the finish was noted at Buildings 49-64 and 65-80 (see Photograph #14).

Photograph #13 – Displaced Metal Hip Cap

Replacement of the metal panel roof systems has been assumed. The estimated service lives of these materials is based upon periodic repairs to the metal panels, including replacement of the paint finishes as required, in order to maintain the integrity of the panel systems.

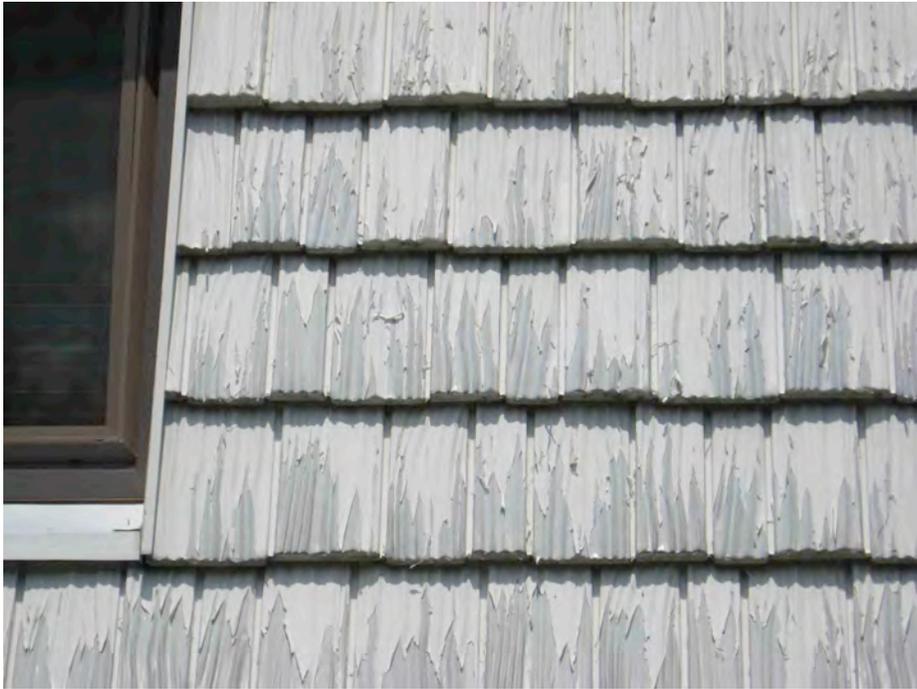
Photograph #14 – Finish Failure At Metal Panels

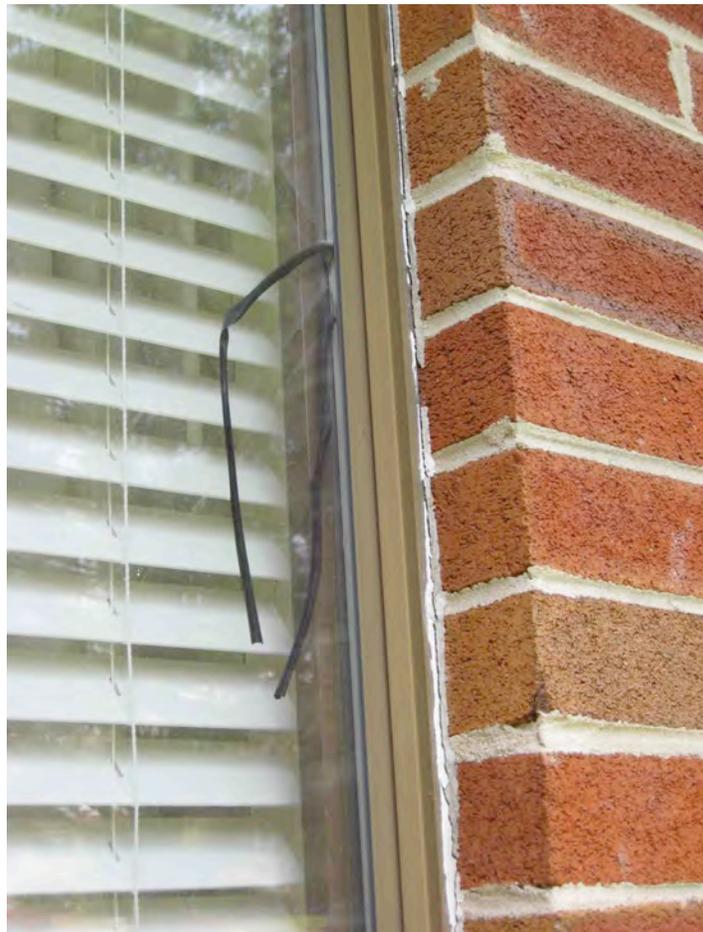
Sealant Joints - The perimeter joints between the window/door frames and masonry are sealed with what appears to be a urethane or butyl sealant. These sealant materials have failed in most areas, with significant crazing and cracking of the sealant (see Photograph #15).

Photograph #15 – Failed Window Perimeter Sealant

Preparation and resealing of the existing sealant joints has been assumed.
