Bergman & Associates, Inc.

**Reference: Inspection - Farrwood Green II
Units 171 and 165**

11 February 10

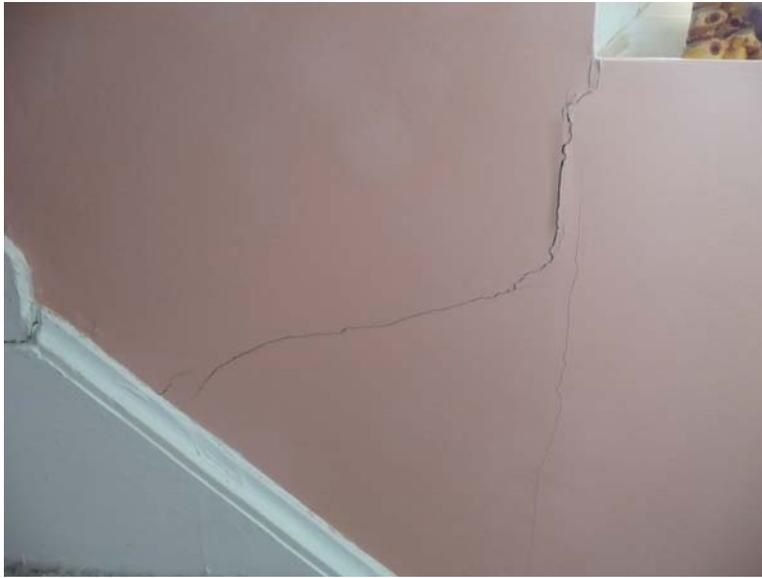
PHOTO 1

Inspection A crack was noted in the interior drywall emanating from the lower left corner of the front picture window, and extending away from the window at an approx 45 deg angle. See Photo 1.

Both cracks are related to settling of the front exterior wall of the unit in this area.

Recommendations For the drywall, I recommend cutting a V notch into the drywall, applying compound, and refinishing. For the exterior crack, cut out the old mortar/caulking and repoint.

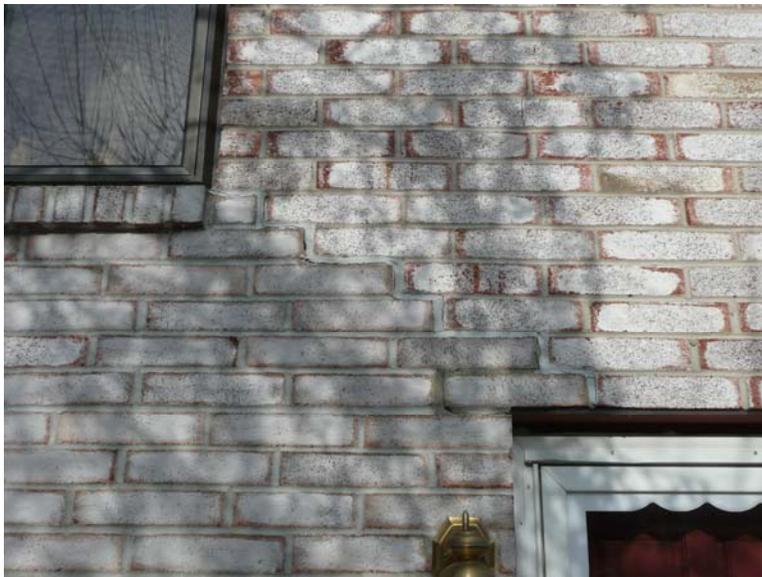
PHOTO 2

A corresponding crack in the exterior brick facade can be seen in Photo 2. This crack has been previously caulked.

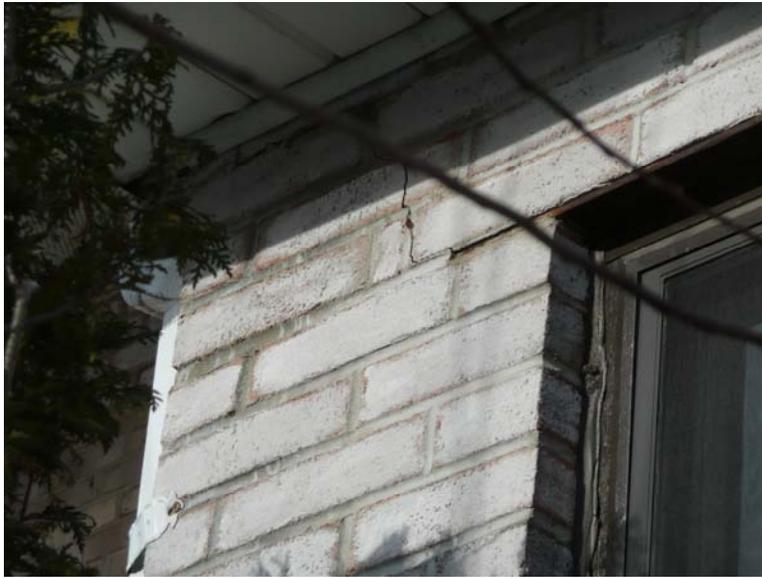
PHOTO 3

Inspection Additional cracks, emanating from window corners, were also noted on the front masonry facade. See Photos 3 and 4. Although somewhat difficult to see, Photo 5 illustrates what appears to be out-of-plane variation in this area of the wall.

Similar to the other cracking, this problem is also due to settling. The out-of-plane variation could be due to either original faulty construction or separation of the exterior masonry veneer from the interior framing.

Recommendations For the cracks, I recommend removing the old mortar and repointing. The out-of-plane variation should be monitored. Although I did not see any signs of distress that would indicate an immediate problem, the wall should be periodically inspected for any additional movement.

Filling of the cracks should not be construed to be permanent solutions to the problems. Any settling of the structure may have already ceased or it may continue. Underpinning of the structure would arrest any further settlement, but I do not think that such a degree of remediation is necessary at this time.

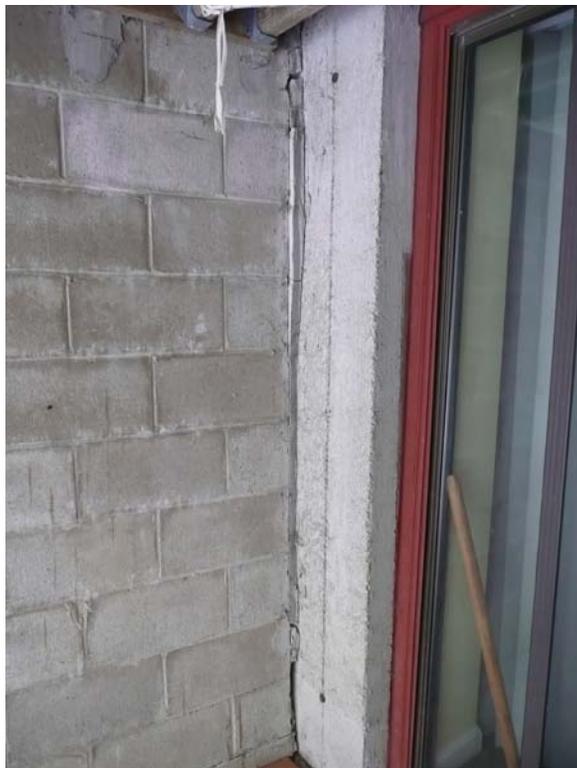
PHOTO 6

Inspection At the rear of the unit, cracks were observed along the intersections of the two (2) demising walls with the foundation walls. See Photos 6 and 7. The causes of and recommendations for repair of these cracks were delineated in a report dated 15 October 08 and previously submitted to your office.

Recommendations Short of removal and replacement with properly designed and constructed walls, caulking and recaulking of these cracks is recommended. I did not observe any signs of extreme distress or imminent collapse.

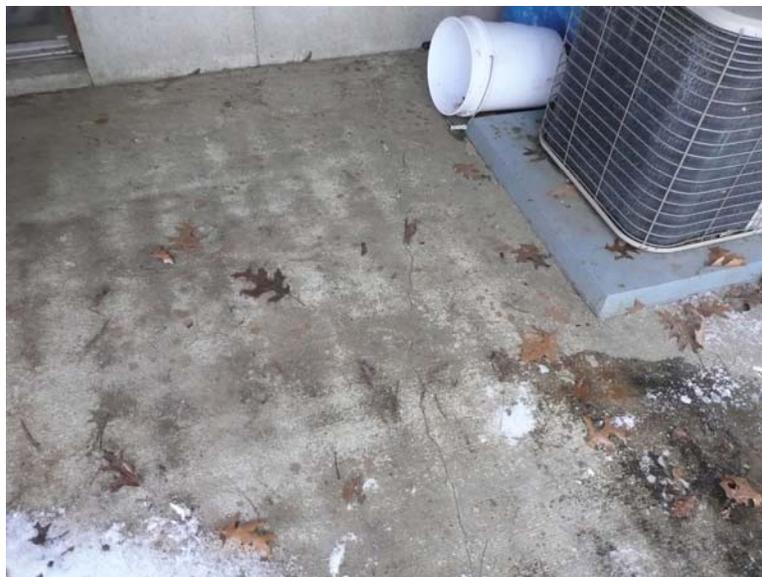
PHOTO 8

Inspection and Recommendations The rear patio deck has cracked and settled. See Photo 8. Also described in the report noted above are recommendations regarding the concrete deck. The cracking I observed did not appear to be cause for concern at this time.

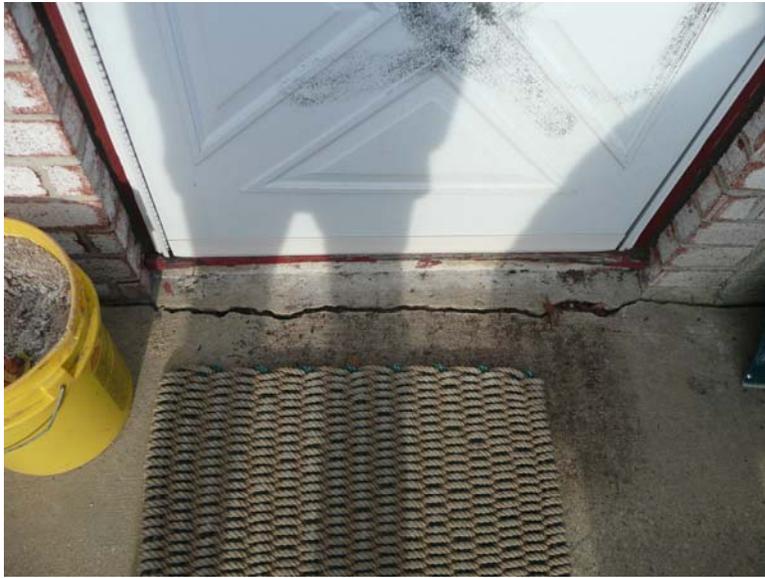
PHOTO 9

Inspection The front stoops has separated from the building. See Photo 9. This photo, although of Unit 171, is also indicative of the problem with Unit 165.

Recommendations I recommend removing the existing stoop and installing a properly designed replacement. I also recommend installing a neoprene gasket in between the new stoop and the foundation wall; the gasket will allow for minor movement of the new stoop with relation to the deck without spalling, etc, of the concrete.
