Reference: Attic Inspections - Buildings A and B

21 April 09

Farwood Attic Inspection – 18 Mar. 2009
UNIT #54

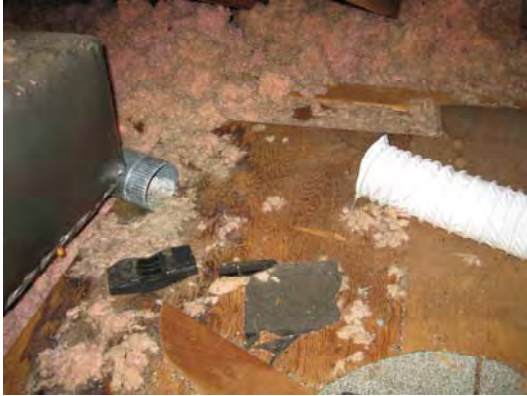
- Bathroom vent disconnected

- Owners should consider increasing insulation levels in 2nd floor ceilings (12" f/g recommended- R38)
- Re-connect bathroom vents to outside (see Unit 54 photos)

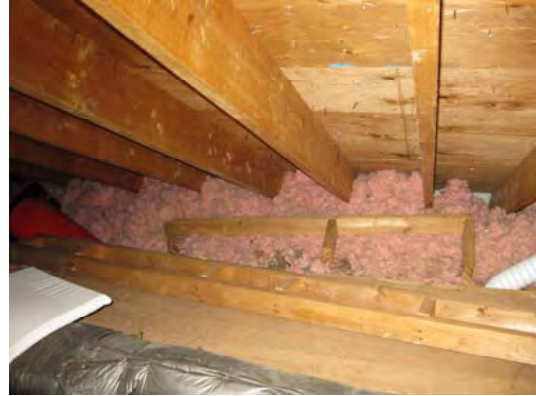
- We do not know the age of shingles, the make, or the installer.
- Three out of four of the attic spaces were well-ventilated (see Unit 55 and 67 photos)
- Unit 54 - rafter bays completely blocked; warm attic (see Unit 54 photos)
- No evidence of roof leaks under bad roof areas
- Possibly some wind-driven snow or rain coming in thru turbine ventilators (see Unit 67 photos)

-Blocked rafter bays

- Work with mfr to specify a new, high-quality roofing system
- Higher (ASTM spec) tear strength for shingles
- Proper substrate and installation
- For shingles to be warranted, mfr will require acceptable framing, sheathing and ventilation
- Different valley roofing technique
- Rafter bay vents in all unit attics
- Ridge vents where none exist presently

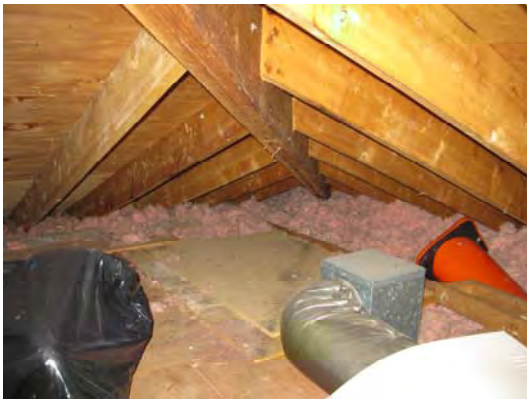
- Blocked rafter bays

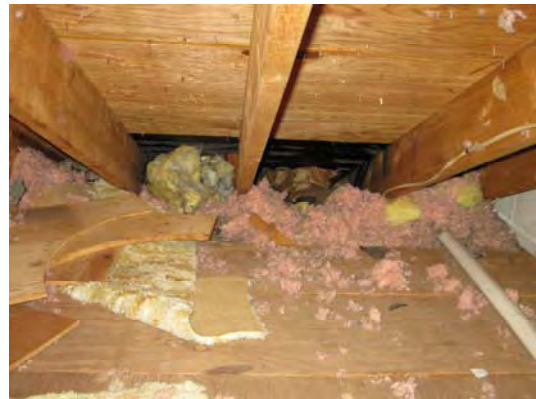
-Blocked rafter bays

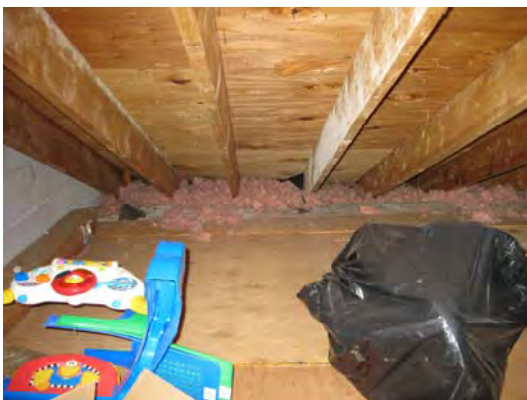
- Blocked rafter bays

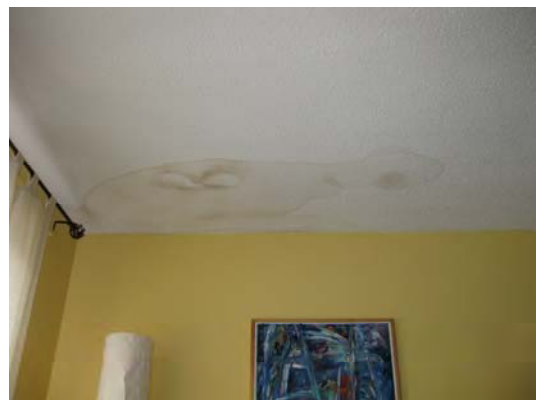
- Ceiling stains appear to be on fore and aft sections of units, adjacent to exterior gutter locations (see Unit 54 photos)
- Heat loss thru pull-down stairs
- Minimal insulation in 2nd floor ceilings (12" f/g recommended- R38)

-Stained 1st floor ceiling (front of unit)

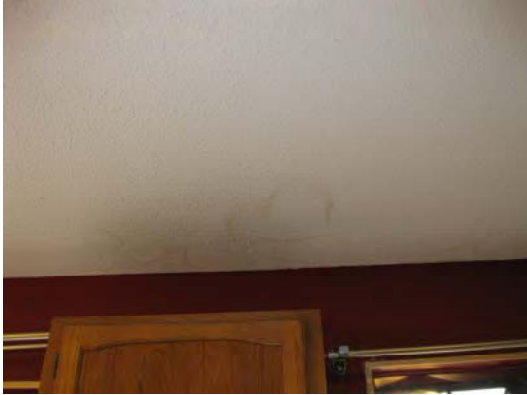
-Stained 1st floor ceiling (rear of unit)

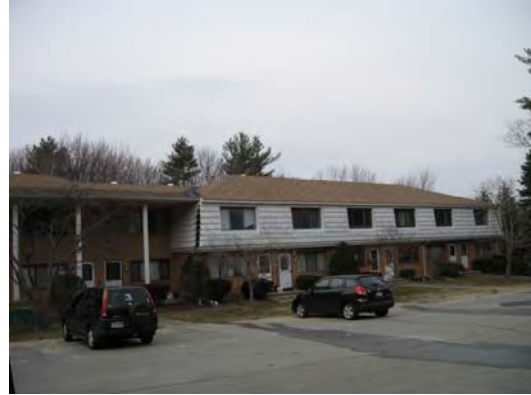
-Tarred valley (front of unit)

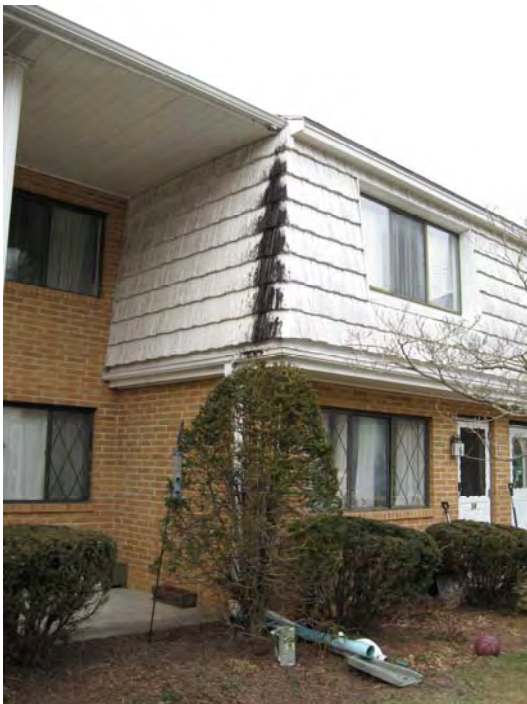
- Bldg A - poor condition. Crushed downspouts; missing leaders; clogged gutters (see Unit 54 photos)
- Rainwater conveyance systems lacking maintenance?
- Ceiling stains and "roof leaks" in the units appear to be from poor condition of gutters,

-Missing down spout (front of unit)

- Repair gutters, downspouts, leaders
- Owners should consider insulated box or some other device to stem heat loss thru pull-

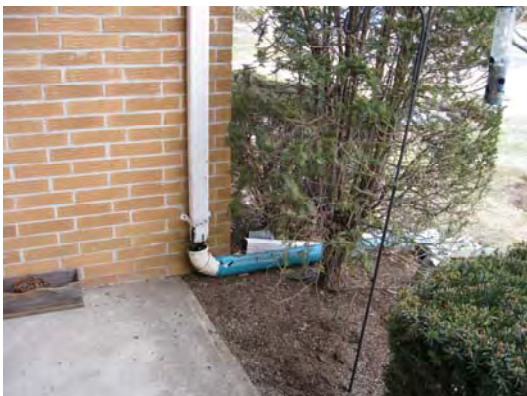
-Disconnected down spout (front of unit)

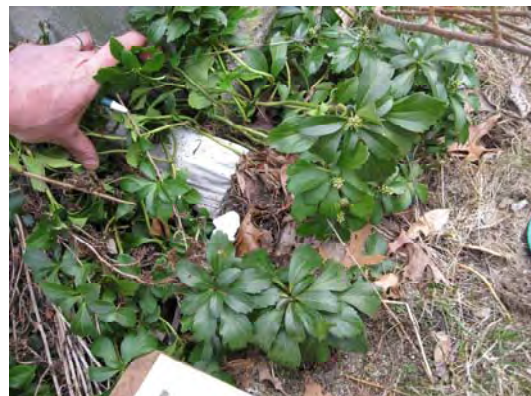
-Blocked downspout (rear of unit)

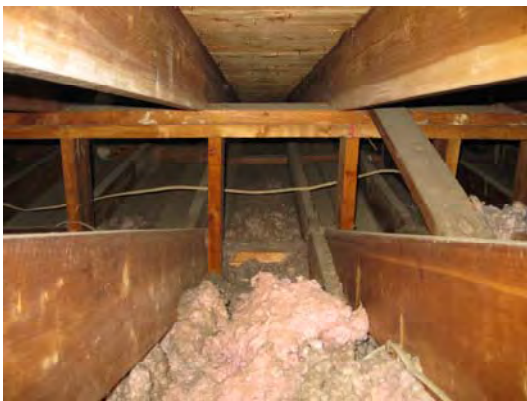
-Open joist bays

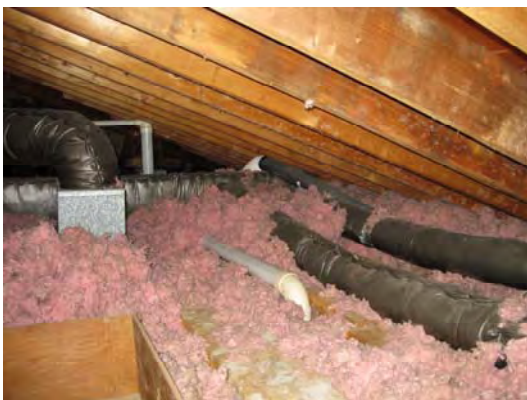
-Well insulated

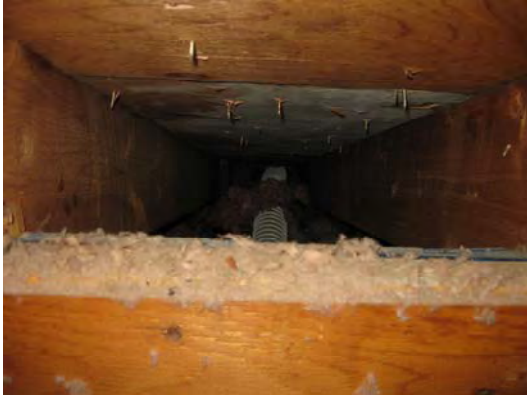
- Unblocked joist bay

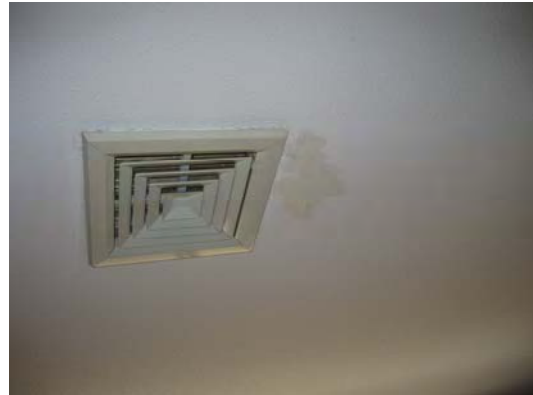
- Water stain on ceiling below turbine vent, wind blown rain possible cause

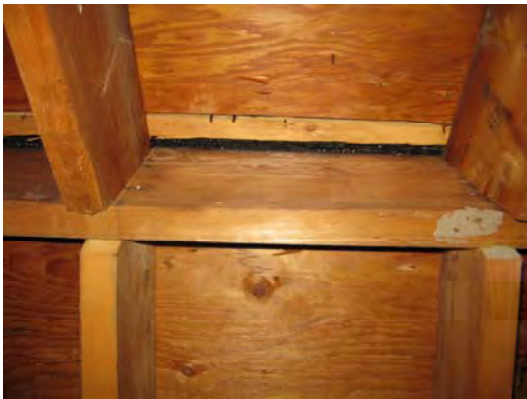
- Installed ridge vent

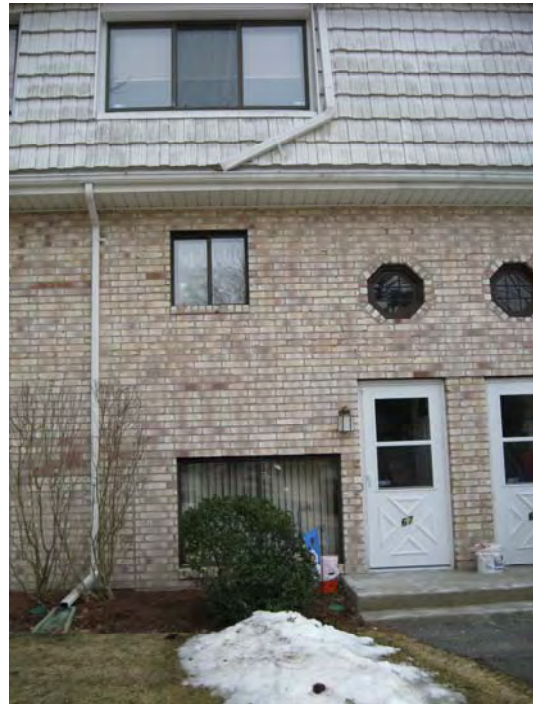
- leaves clogging upper down spout (front of unit)

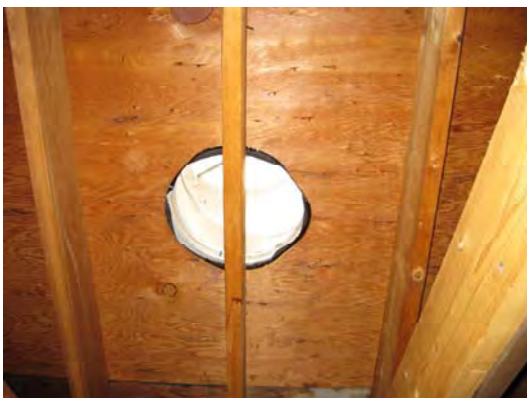
- Installed turbine vent
- No staining on plywood

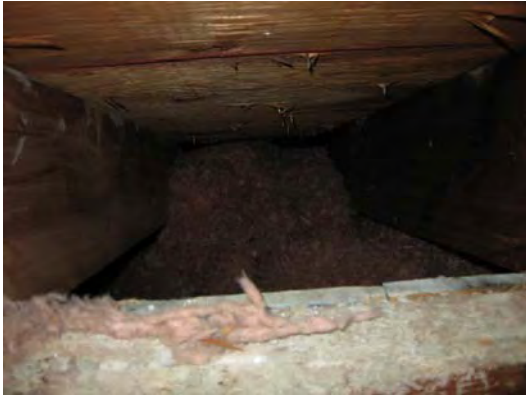
-Blocked joist bay

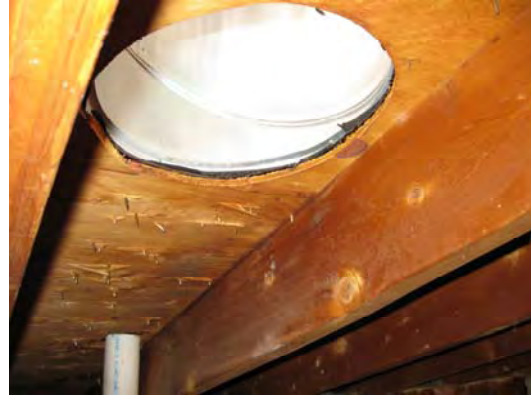
-Turbine vent, no plywood staining

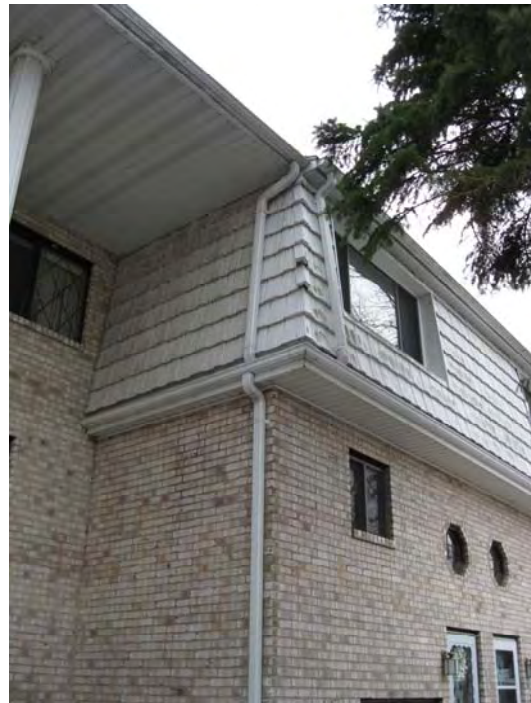
-Hip flashing broken/bent
